# **TAIWAN'S 921 QUAKE AND WHAT IT MEANS TO THE SEMICONDUCTOR INDUSTRY**

***Brian Sherin, CSP, EORM, Inc. and Stacy Bartoletti, PE, Degenkolb Engineers***

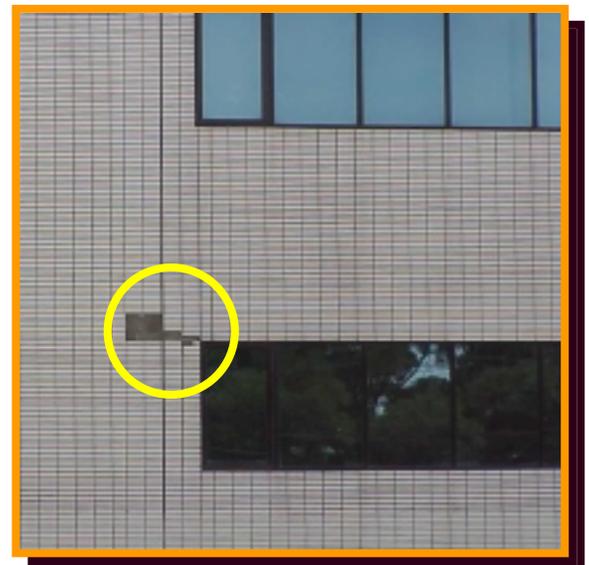
Because of the distance of the HSBIP from the epicenter, much of the acceleration was attenuated. As expected for accelerations in the 10%g range, there was very little structural damage. No damage to the exterior window wall systems in the steel frame structures was observed. Similarly no major damage other than minor cracks on the interior partition walls was either reported or observed. Some minor cracking and spalling of the exterior tile on the reinforced concrete structures was observed as shown in Figure 4. This damage was generally caused by the working and cracking of the concrete frame and concrete or masonry infill walls behind the tile facade and was found to be very minor on most buildings.

Figure 4. Typical exterior damage observed in the Science Park — spalling or flaking of architectural finish tiles.

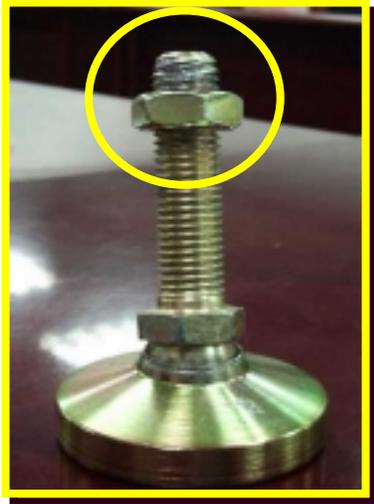
Very little physical damage or movement of process or facilities equipment was observed. In fact, this investigation team only found one or two pieces of equipment that appeared to move at all during the earthquake. This lack of movement and damage is primarily attributable to the low level of acceleration observed at the site. In most cases that were observed, equipment was either not anchored or was not anchored appropriately. It was reported by other parties, that many pieces of equipment in one facility moved an average of 1 to 3 cm. Furthermore, there were some process tools that suffered damage to the leveling feet on which the chassis stands. These feet are attached to the tool chassis by threaded rods. If the chassis is raised to the point where these rods are only threaded by 2-3 turns, they can be ripped out if the tool shifts laterally. Figure 5 shows an example of a foot that was torn from the chassis into which it was attached. It was observed in the facilities that were visited, that this practice of raising the tools up to the maximum height on these feet is commonplace. In one situation it was even observed that a tool was raised a further few inches by inserting several metal shims between the foot and the floor.

Figure 5. Example of process equipment leveling foot that pulled out of the equipment chassis. Note how high up the threaded rod the bolt is located and the stripping of the upper few threads. Raising the equipment up to the maximum height of the foot is a common practice. Equipment makers should provide further guidance on the minimum number of threads that should go into the chassis or re-design the rods to ensure that there
