# **TAIWAN'S 921 QUAKE AND WHAT IT MEANS TO THE SEMICONDUCTOR INDUSTRY**

***Brian Sherin, CSP, EORM, Inc. and Stacy Bartoletti, PE, Degenkolb Engineers***

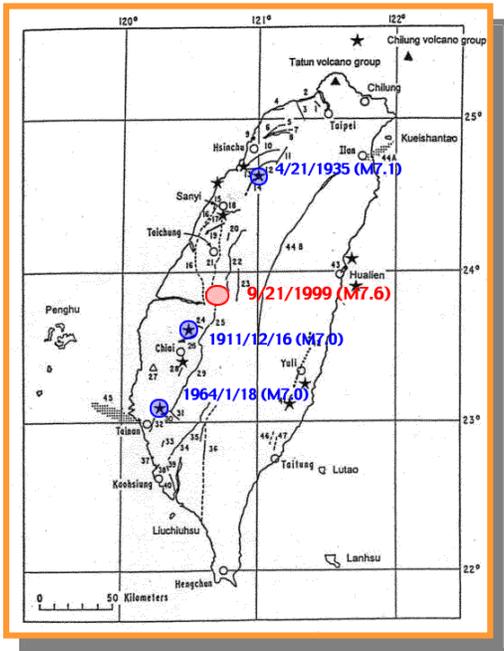
At 01:47:19 local time on September 21, 1999 a magnitude (M) 7.6 earthquake occurred near the town of Chichi (in Nantou County). The earthquake occurred along the Shungtung and Chelungpu faults as shown on Figure 1. These faults are produced by the intersection of Ryukyu and Manila trenches with the continental margin of Asia (Figure 2).

Figure 1. Map of Taiwan showing the epicenter of the 921 Quake and several other notable quakes in the past 100 years, including one outside of Hsinchu in the north and one outside of Tainan in the south (both semiconductor industry locations).

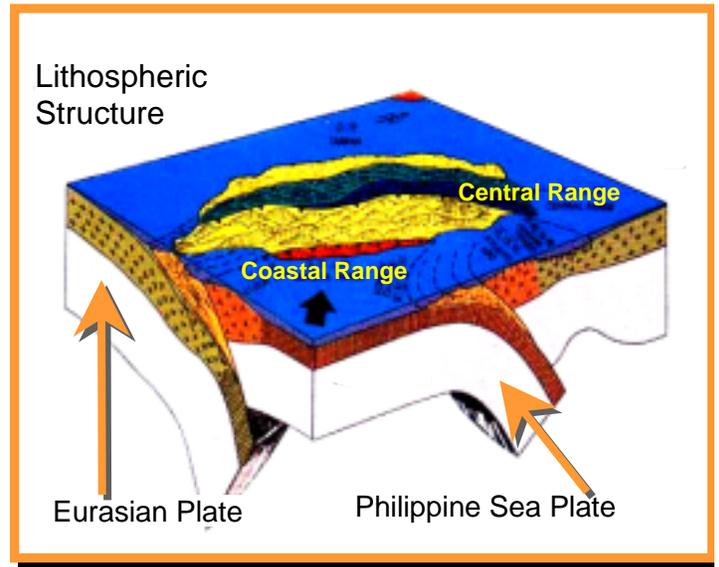
Figure 2. Diagram showing a cross section of the plate tectonics that form Taiwan. Typically, plate boundaries either slide against each other (strike-slip) or subduct (thrust). Taiwan's complicated seismic structure includes two subduction boundaries (Eurasian into the Philippine Plate and the Philippine into the Pacific Plate). The Central Range (location of the 921 Quake) is formed by material that piles up (accretion) as the Eurasian plate dips down below the Philippine. This geology produces parallel bands of seismic activity on both sides of the island.

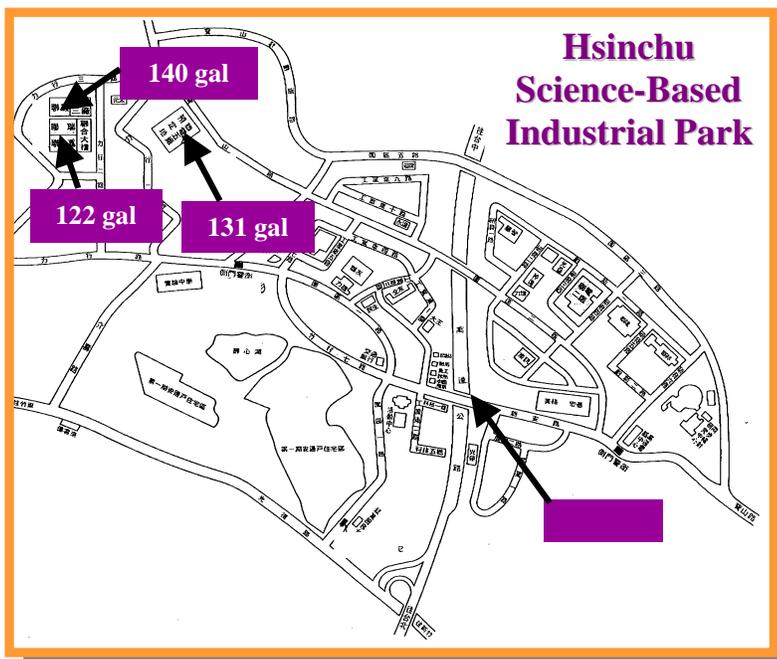
The vast majority of the microelectronics industry in Taiwan is located in the Hsinchu Science Based Industrial Park (HSBIP) in the city of Hsinchu. The science park is located approximately 110 km north of the earthquake epicenter as shown on Figure 1. Several of the wafer fabrication facilities are equipped with accelerometers that are used to trigger shutdowns of hazardous gas delivery. Based on acceleration data from these devices, the PGA in the park was on the order of 0.10 g (98 cm/s<sup>2</sup>) to 0.15 g (147 cm/s<sup>2</sup>). Figure 3 is a map of the HSBIP with recorded PGA and locations shown.

Figure 3. Map of the Hsinchu Science-Based Industrial Park (HSBIP) showing acceleration readings from hazardous gas shutdown switches (accelerometers)

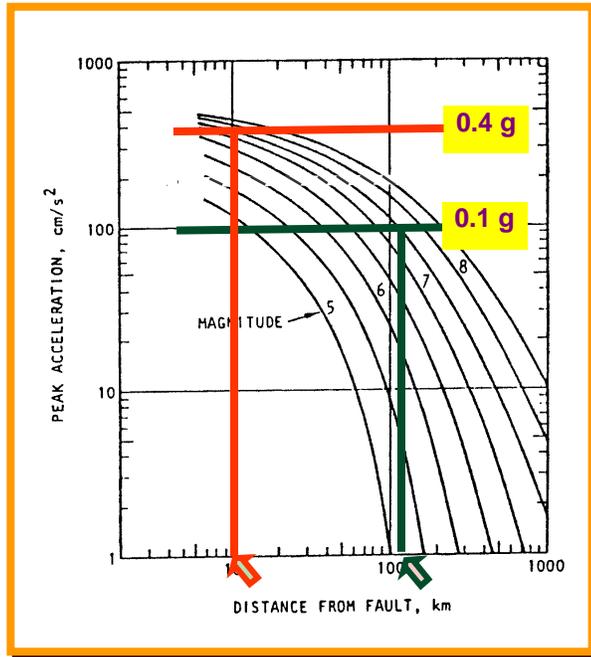
The accelerations that were observed in the HSBIP are very close to what would be expected from a M7.6 earthquake that occurred more than 100 km away. The relationship between distance from an earthquake fault rupture, the magnitude of the quake, and the PGA can be plotted in what is known as an attenuation diagram. Figure 6 shows an idealized attenuation diagram. The contours from an actual earthquake will be much more irregular, because of inhomogeneities in the earth's crust, non-uniform movements of the fault, and local soil conditions. In addition, the near-field effects can be affected by the depth of fault rupture, the direction of the fault movement, etc.

Figure 6. Idealized attenuation diagram showing the relationship between distance from the fault and the expected PGA. Hsinchu is approximately 110 km from the epicenter of this quake; therefore distance would attenuate the acceleration from a M7.5 to approximately 0.1 g which is what was recorded by accelerometers in the Park. If a comparable sized quake occurred on the Hsinchu fault, or another one in close proximity to the Park, acceleration could approach or exceed 0.4 g.
